FULL SCALE EXTERIOR WALL TEST ON THE SAGIWALL PVD BOARD

Client Report: A1-006326

14 May 2015

This report describes a full-scale exterior wall fire test conducted on April 30, 2015 on the SAGIWALL PVC BOARD. The test was conducted in accordance with CAN/ULC-S134-13, Standard Method of Fire Test of Exterior Wall Assemblies.

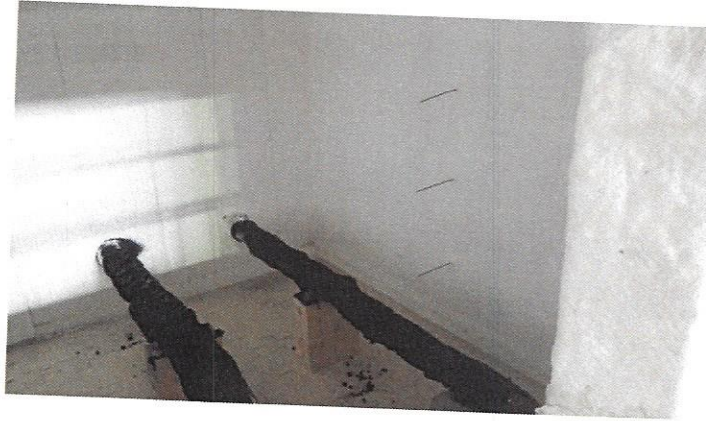
The fuel source in the burn room consisted of four 3.8 m long linear propane burners spaced equally along the width of the room and mounted 0.6 m above the surface of the paving stones (see Figure 3).

Figure 3. Propane Burners and Room Thermocouples.

Room Temperatures – The burn room air temperature was monitored by six Type K thermocouples, enclosed in 6 mm outside diameter Inconel sheaths. The thermocouples were introduced through the side walls with the measuring tips 0.6 m from the inner surface of the wall. All room thermocouples were located on the vertical centerlines of the side walls (see Figure 3).

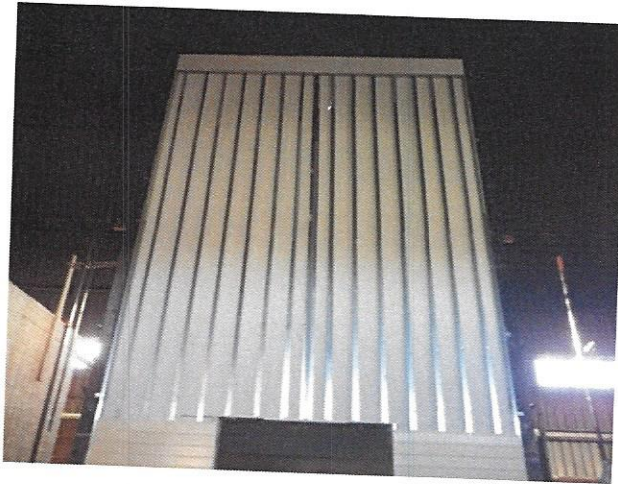
Galvanized 38 mm Z type bars were fastened vertically to the structure using concrete anchors at 400 mm centers. As shown in Figure 4, the Z-bars spanned the entire height of the wall with no interruption (except for the window) allowing a 35 mm air barrier between the drywall and the test samples. Extruded aluminum channels were installed vertically at the outer edges of the assembly and at the centerline. The Sagiwall planks were mounted horizontally and fastened using self-tapping screws. The planks interlocked by using an integrated tongue and groove system. Aluminum trim caps were applied to all the edges of the assembly and in the center where the planks joined at the vertical joint. The only vertical joint of the assembly spanned the entire wall height on the centerline. The assembly incorporated four horizontal joints between 2.4 and 3.0 m.

Figure 4. Wall System Under Construction.

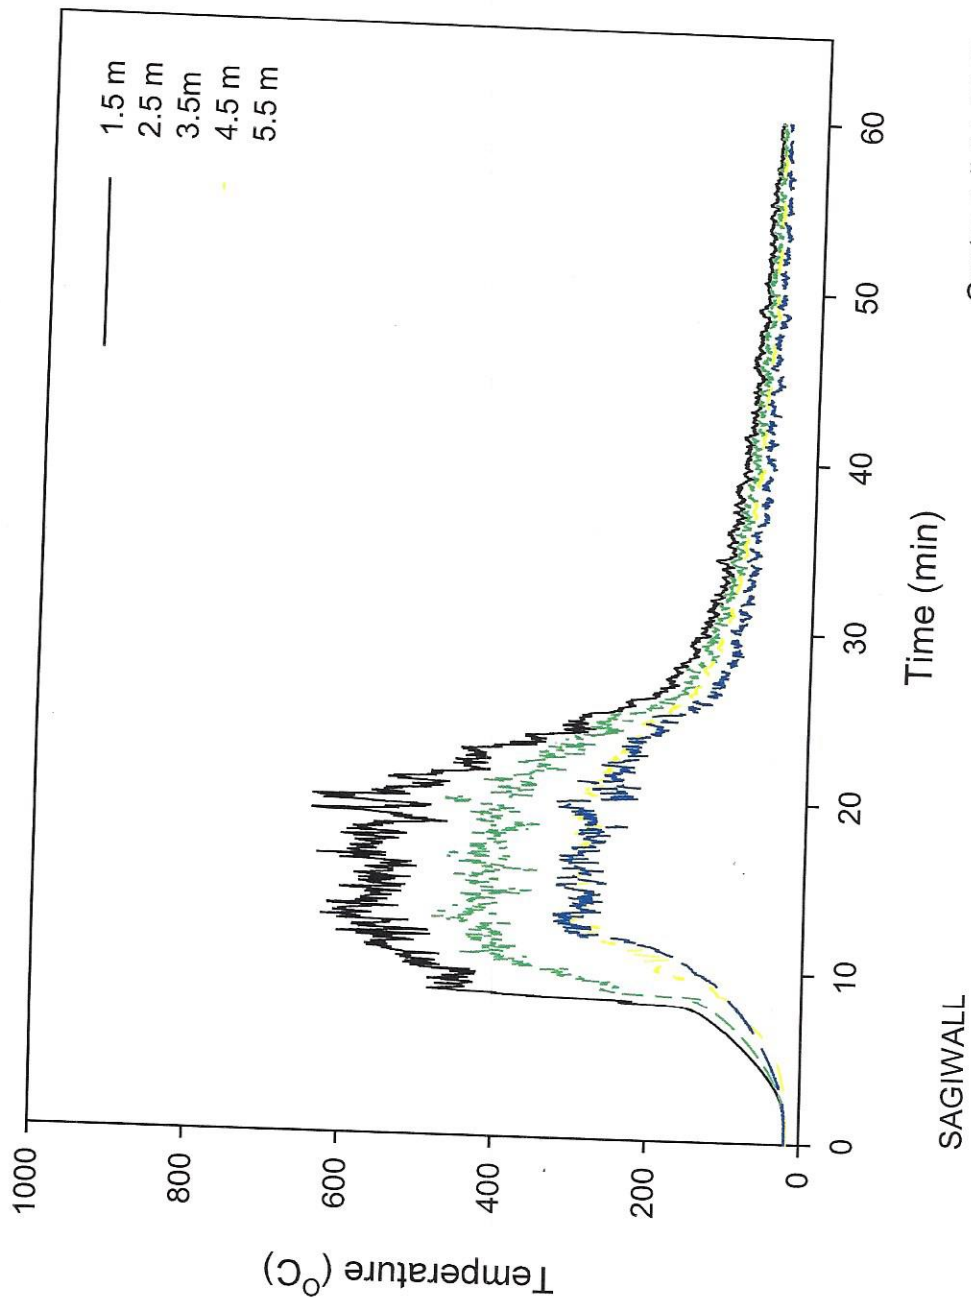
The temperatures recorded by the thermocouples installed behind the exposed layer are shown in Figure 10. The maximum temperatures at 1.5 m, 2.5 m, 3.5 m, 4.5 m and 5.5 m above the window opening were 640°C, 537°C, 480°C, 326°C and 326°C, respectively.

Figure 10. Temperatures behind the exposed panels.

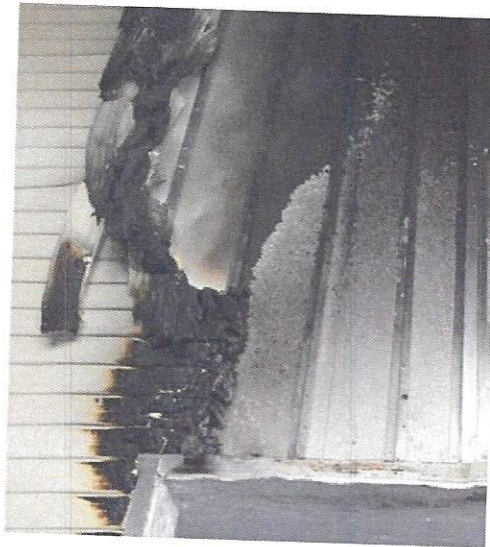
The Sagiwall planks started to char at five minutes from ignition. After a brief flare-up at 6:28, the fire remained stable and burned in a typical manner. Debris fell to the floor until the planks immediately above the window were completely consumed. The planks that were not consumed by the flames ended up melting away from the heat source and drooping down (see Figure 14).

Figure 14. Melted and charred Sagiwall Planks.

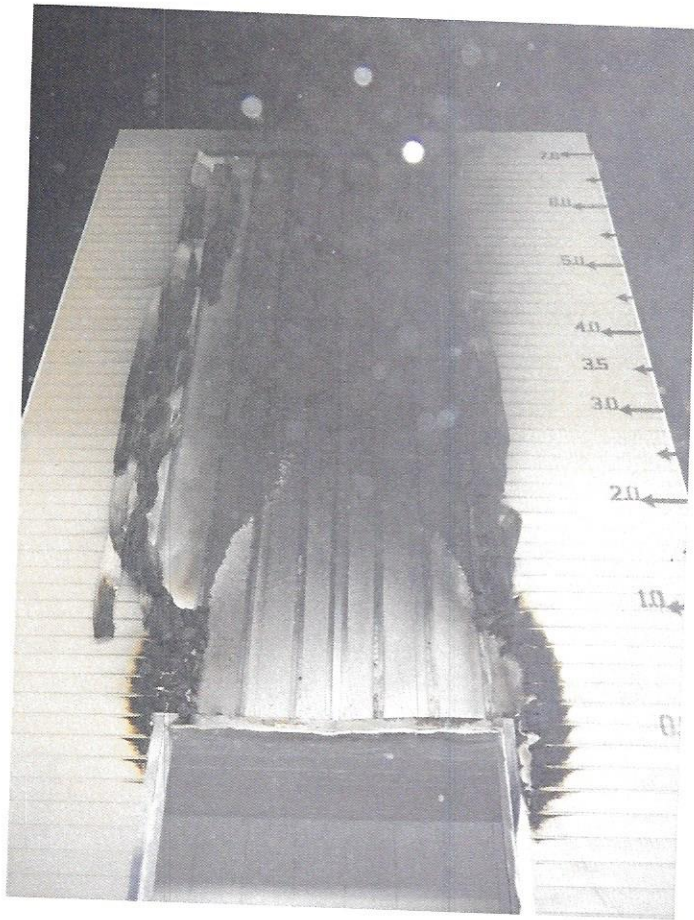
Figure 16 shows the extent of the damage to the wall sample after the test.

Figure 16. Wall Sample after Fire Exposure.

2. The damage on the specimen extended to the top of the wall assembly (7 meters above the window).
3. During the fire exposure, there were flames up to the 3.0 m mark. This is less than the 5 m limit for flame spread distance specified in Sentence 3.1.5.5.(3) and defined in Appendix A (A-3.1.5.5.(3)) of the 2010 edition of the National Building Code of Canada.
